UNITED STATES ENVIRONMENTAL PROTECTION AGENCY

SUBJECT: Inspection Report Transmittal to Ledgeview Farms, LLC

On April 9, 2015, EPA conducted an inspection of your facility, Ledgeview Farms in De Pere, Wisconsin. The purpose of the inspection was to evaluate compliance with the Clean Water Act (CWA) and Administrative Order V-W-13-AO-22. Ledgeview Farms is a large Concentrated Animal Feeding Operation (CAFO) as defined in 40 C.F.R. § 122. During the inspection, we observed violations of the CWA and Administrative Order. The CWA and Order requires you to immediately cease all unauthorized discharges.

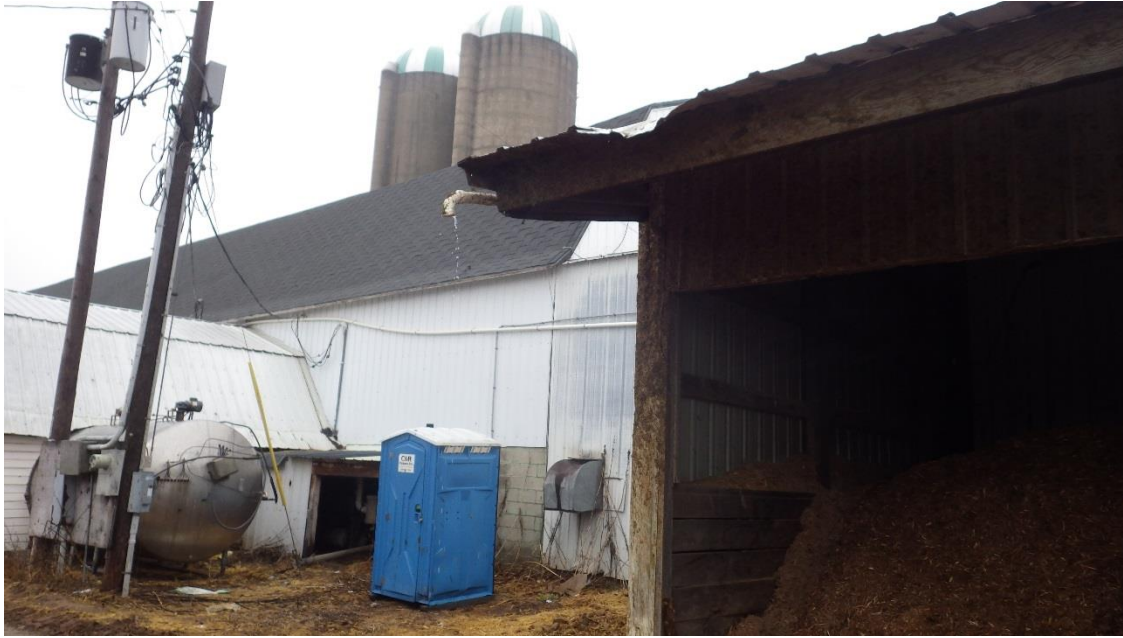
84: RIMG0093

Description: Manure and waste materials were observed on the ground along an access way between the barns.

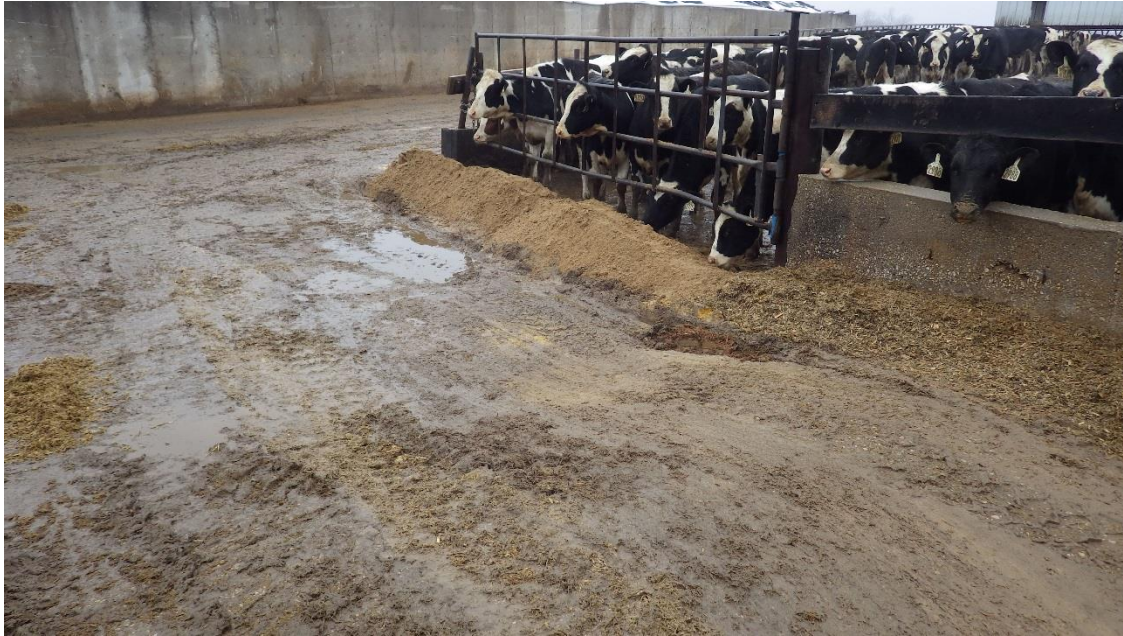
Description: Feed and manure on the concrete east of Lot D.

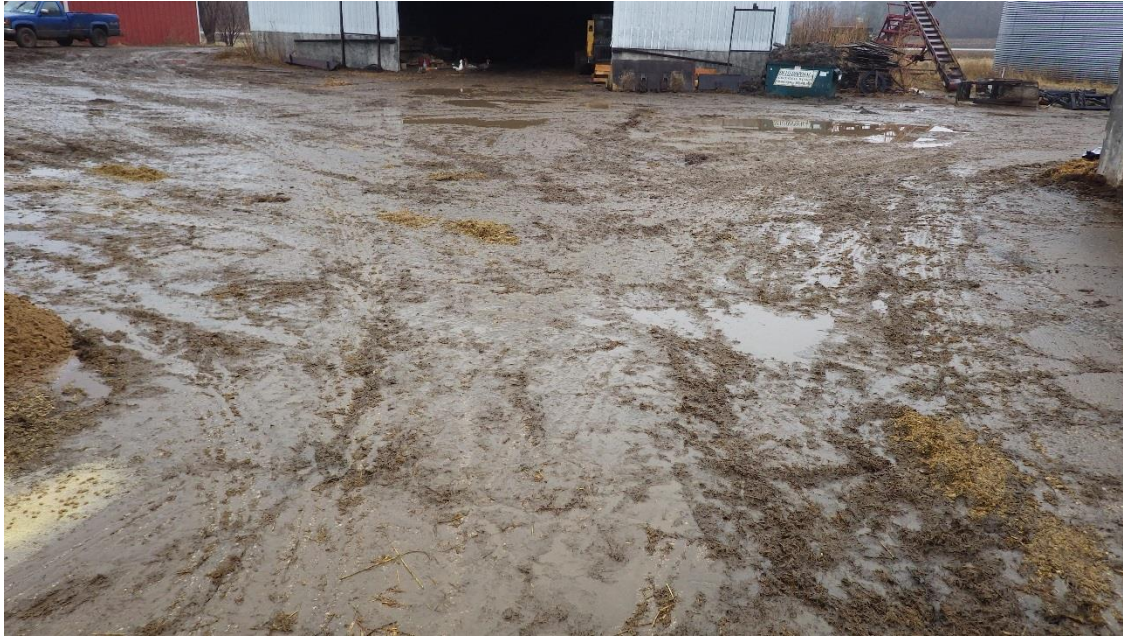
Description: A sand berm had recently been placed at the access gate for Lot D. Manure and process wastewater were observed east of the access gate on the concrete.

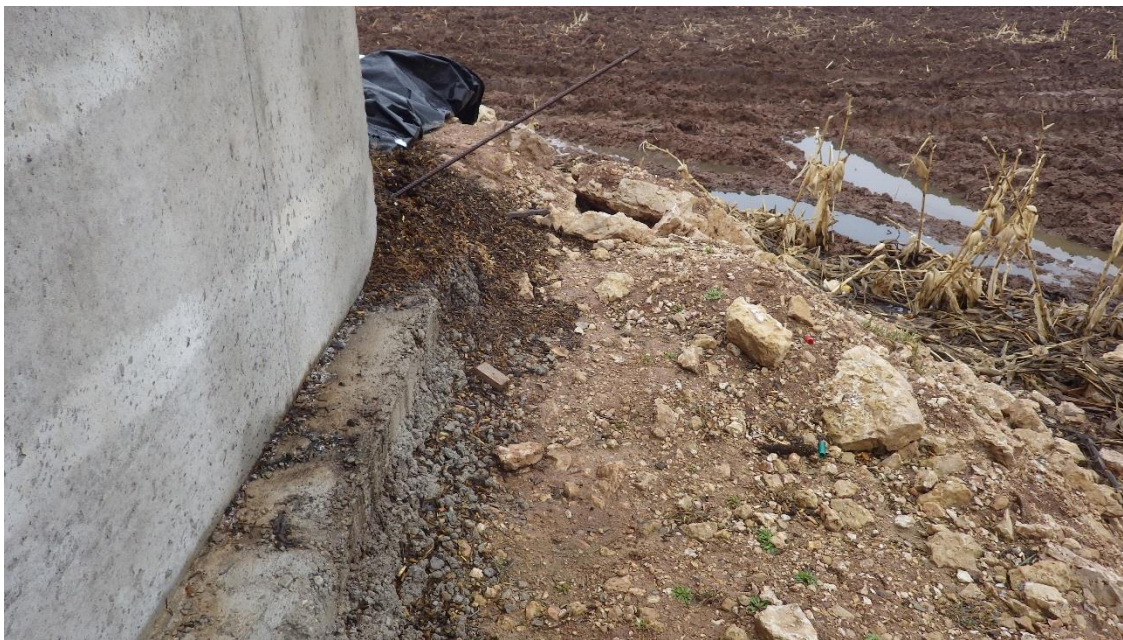
101: RIMG0110

Description: Leachate was observed outside of the bunker wall.

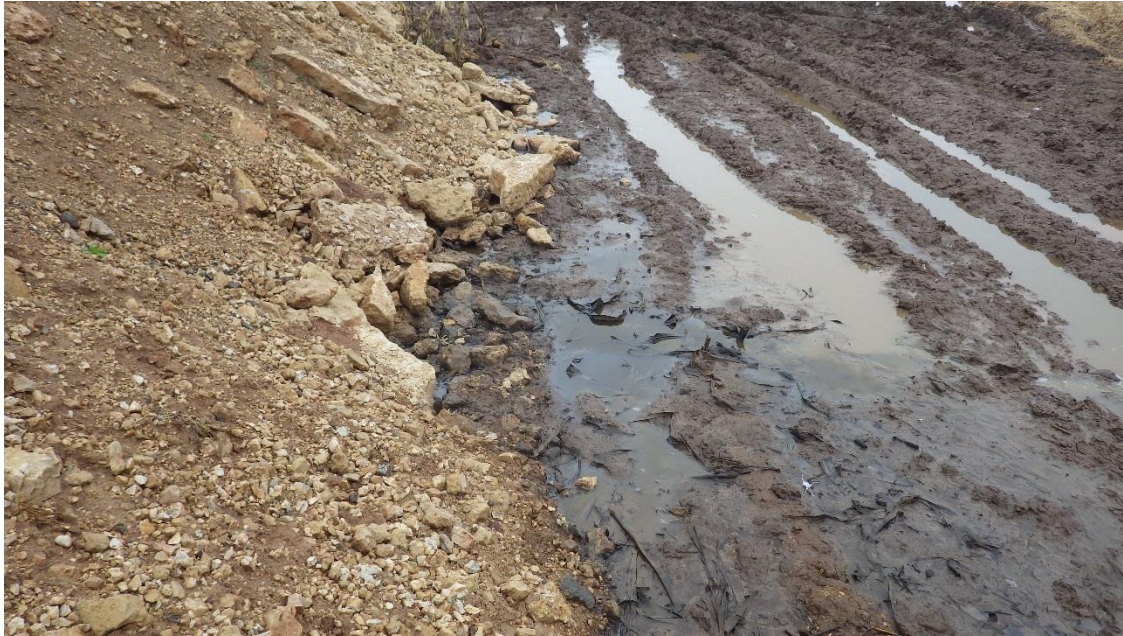
Description: Leachate was observed outside of the bunker wall and was draining through the rock/soil and then overland to the unnamed tributary.

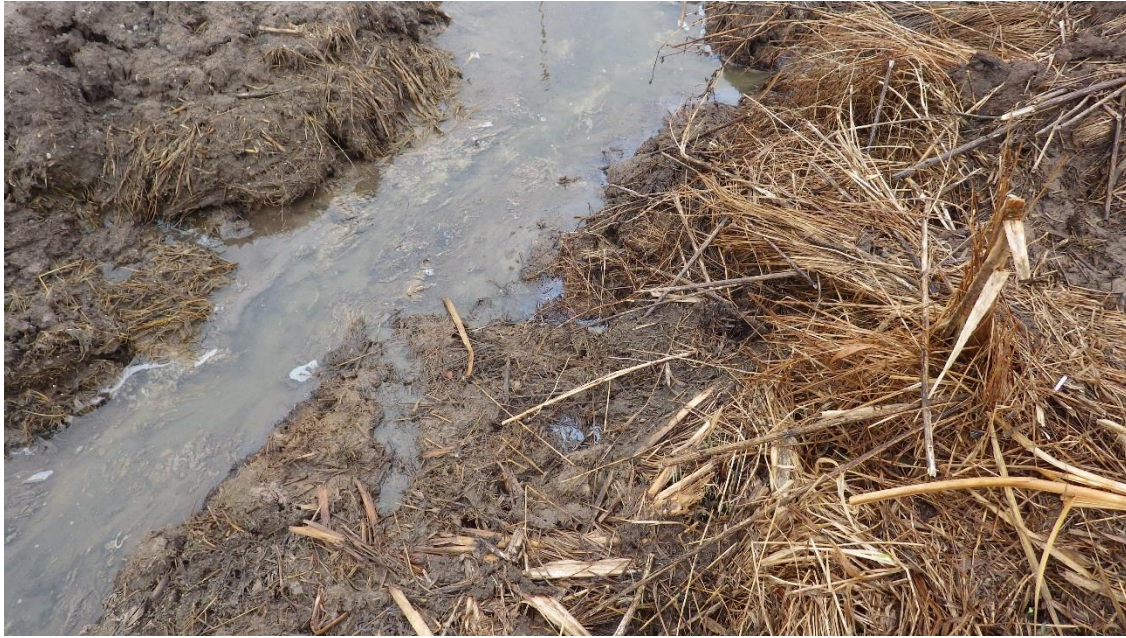
Description: The leachate was draining west through tire ruts and into the unnamed tributary.

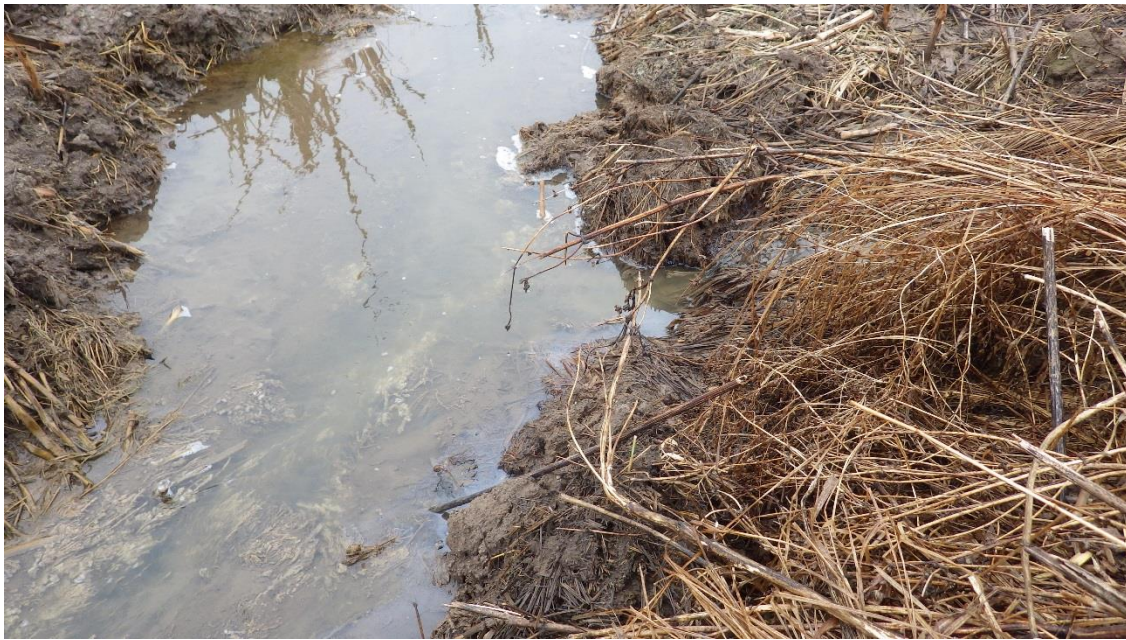
111: RIMG0120

Description: A sheen was observed where the leachate entered the unnamed tributary.

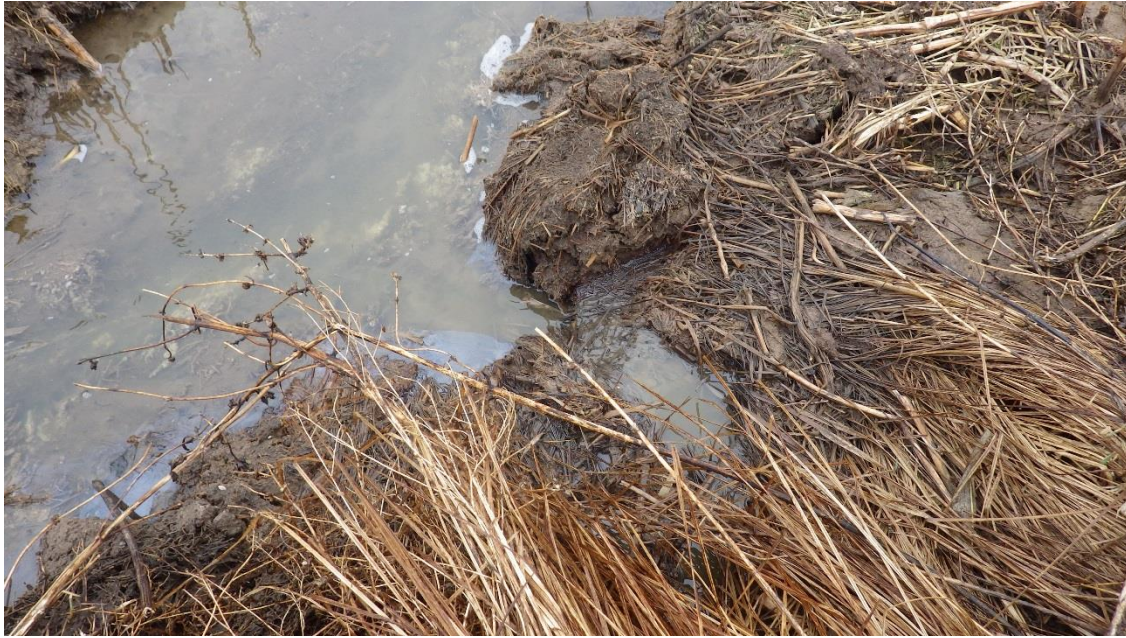
112: RIMG0121

Description: A sheen was observed where the leachate entered the unnamed tributary.

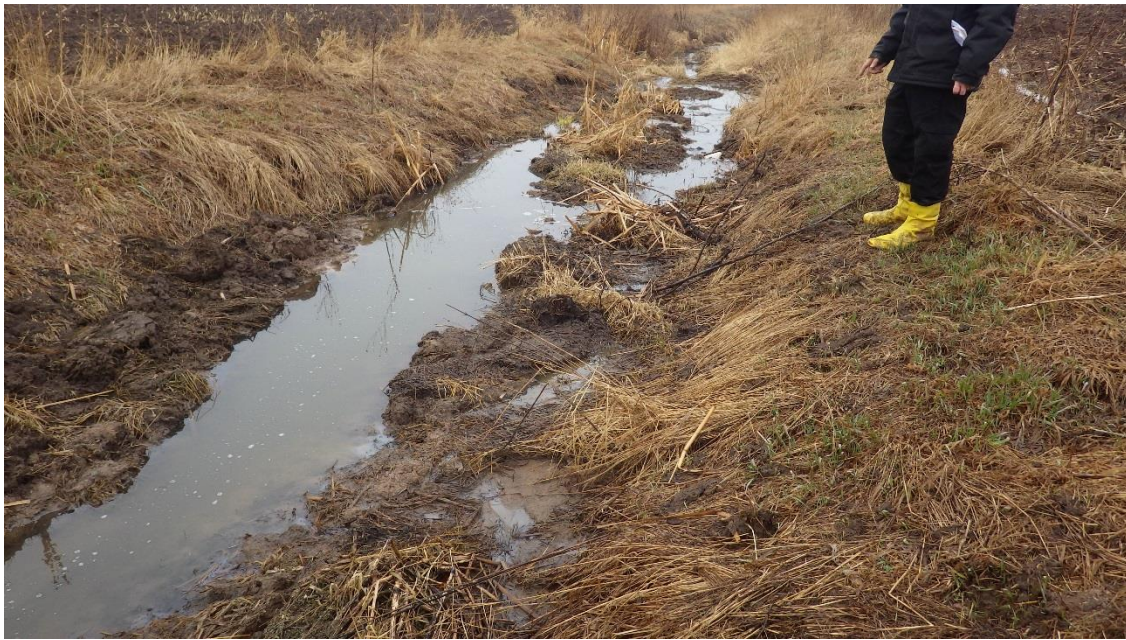
113: RIMG0122

Description: A sheen was observed where the leachate entered the unnamed tributary.

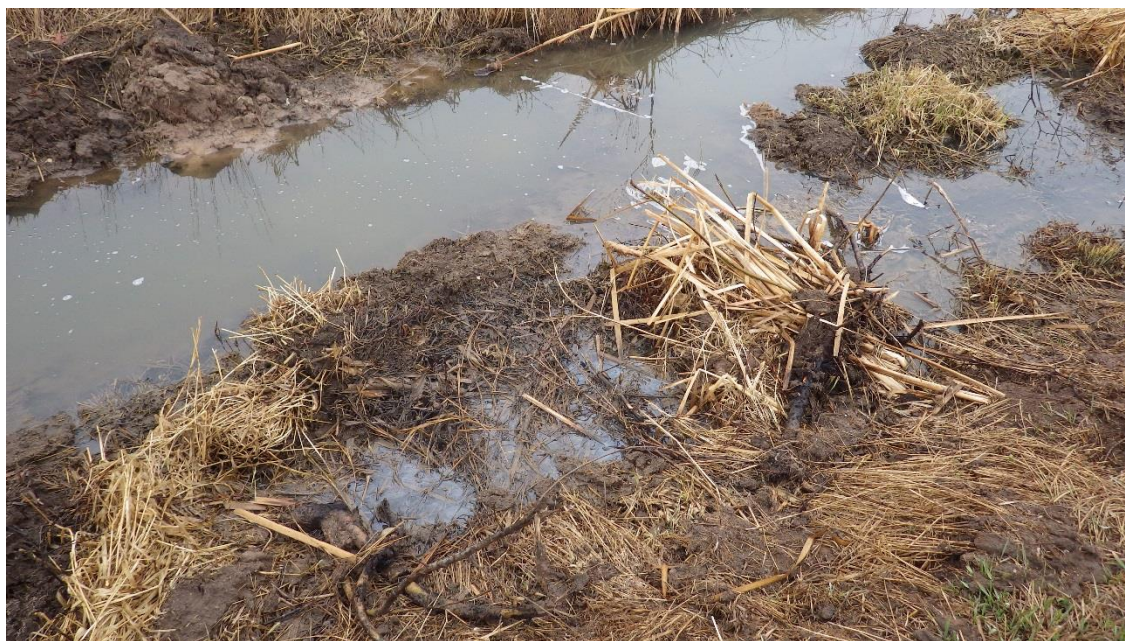
114: RIMG0123

Description: A sheen was observed where the leachate entered the unnamed tributary.

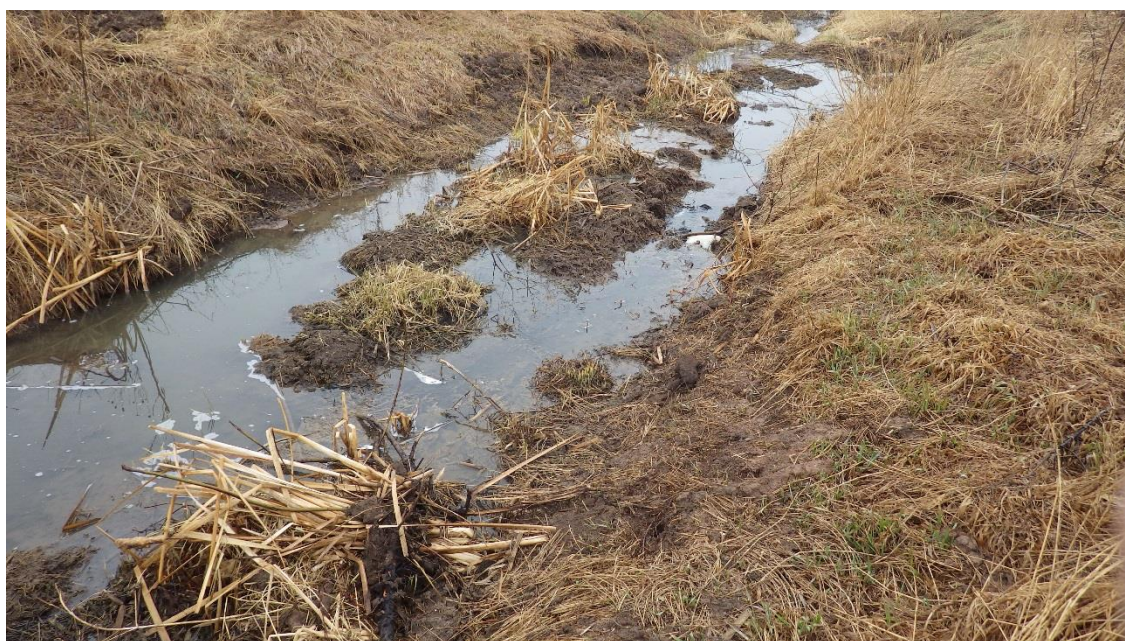
115: RIMG0124

Description: A sheen was observed where the leachate entered the unnamed tributary.

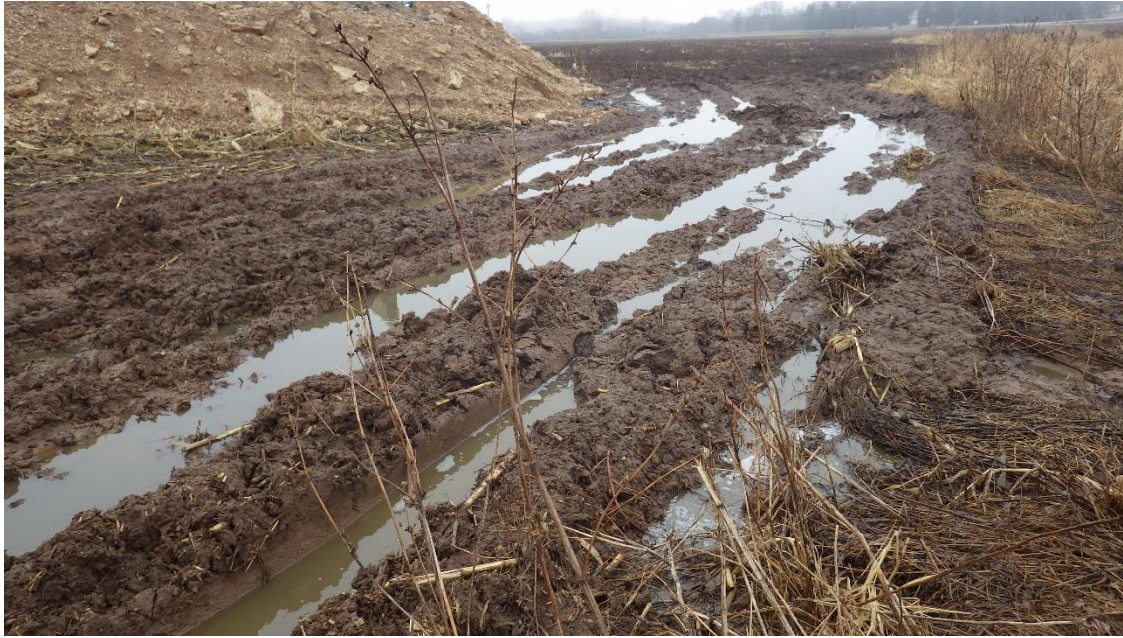
116: RIMG0125

Description: A sheen and foam was observed where the leachate entered the unnamed tributary.

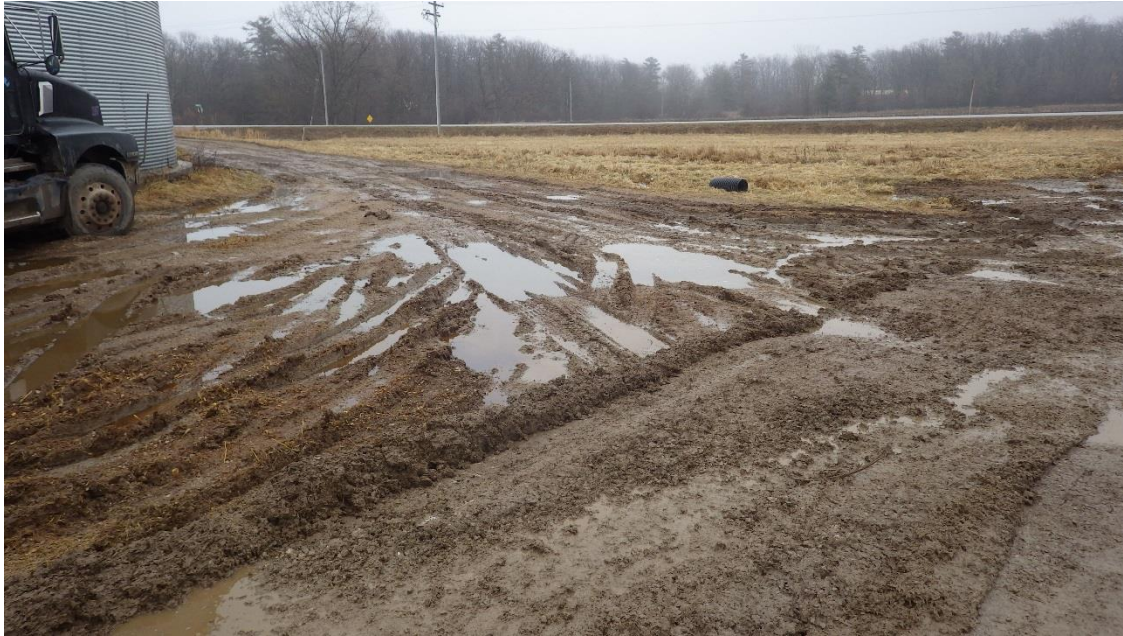
Description: Process wastewater and feed solids were observed around the feed bunkers. The process wastewater was ponded and flowed east into a grassed area. Drainage from most portions of the feed bunkers flowed east into a grassed area and to a ditch.

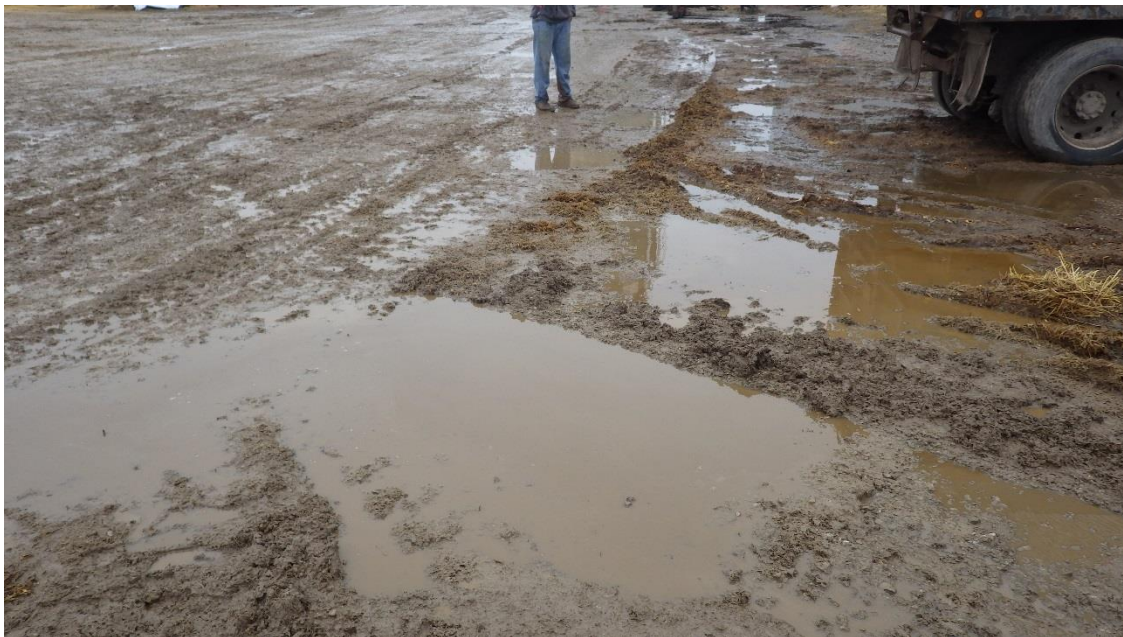
129: RIMG0138

Description: Process wastewater and feed solids were observed throughout the grassed area and the drainage paths leading to the grassed area.

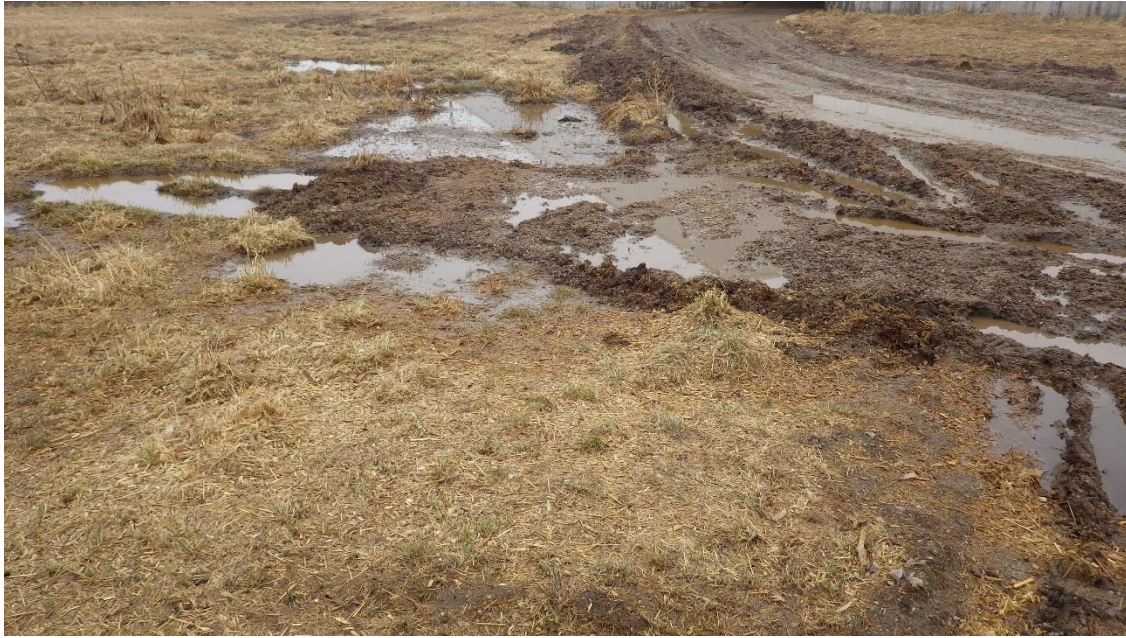
130: RIMG0139

Description: Process wastewater and feed solids were observed throughout the grassed area and the drainage paths leading to the grassed area.

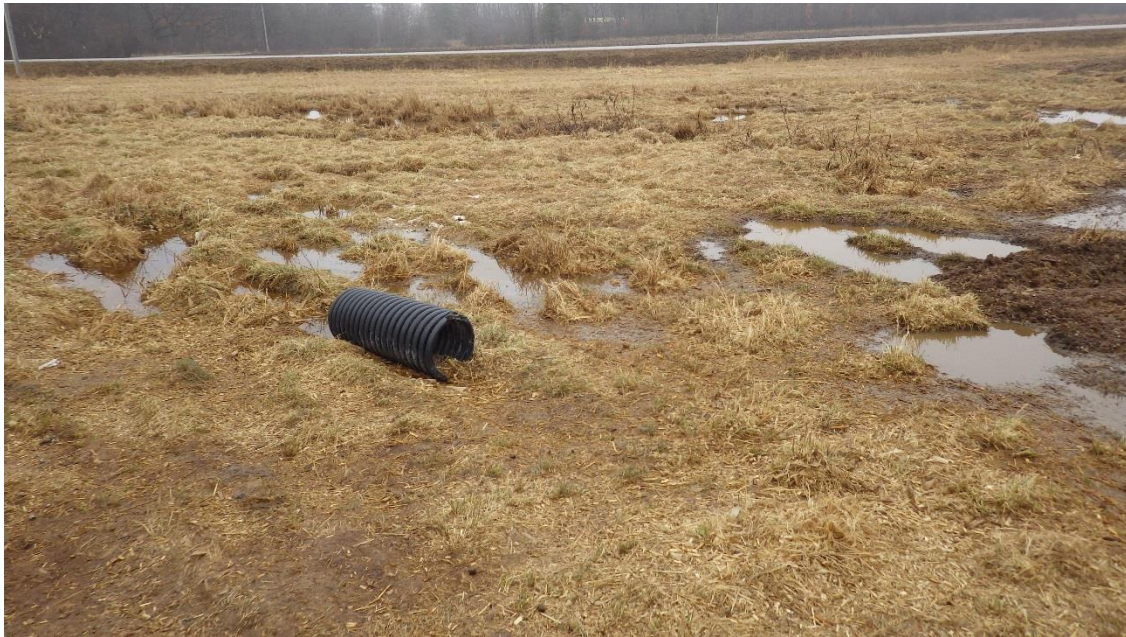
131: RIMG0140

Description: Process wastewater and feed solids were observed throughout the grassed area and the drainage paths leading to the grassed area.

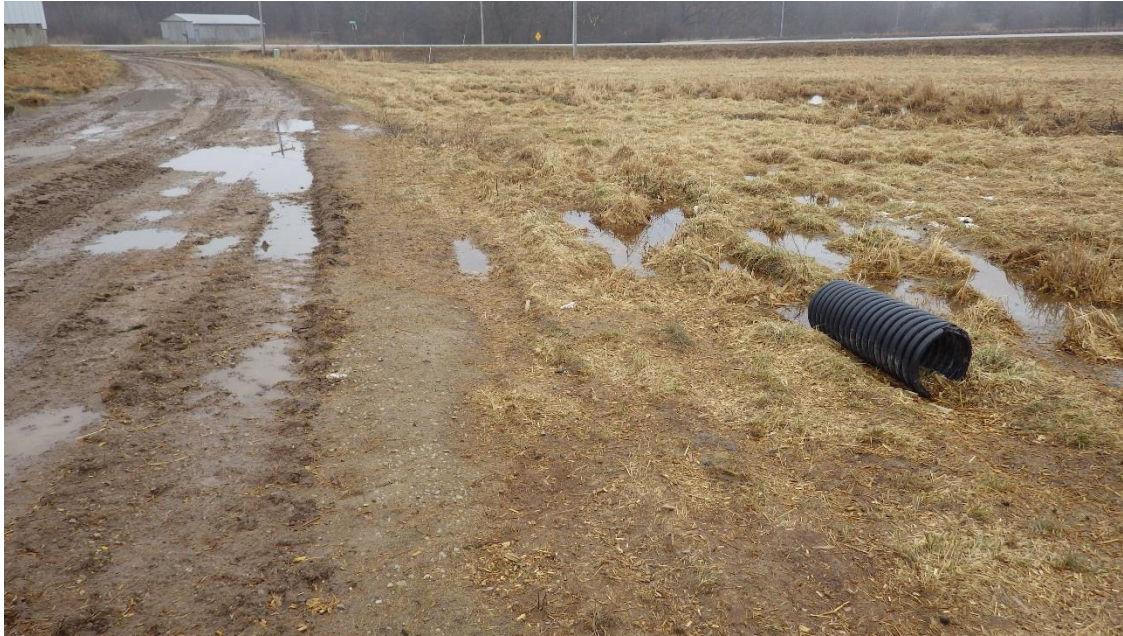
132: RIMG0141

Description: Process wastewater and feed solids were observed throughout the grassed area.

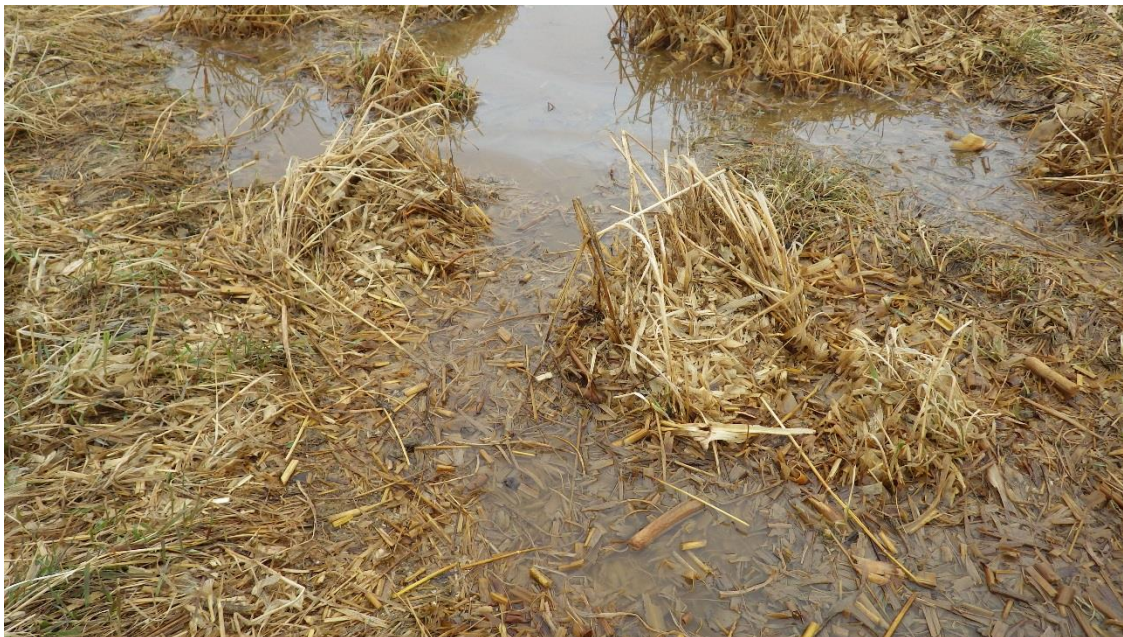
133: RIMG0142

Description: Process wastewater and feed solids were observed throughout the grassed area and the drainage paths leading to the grassed area.

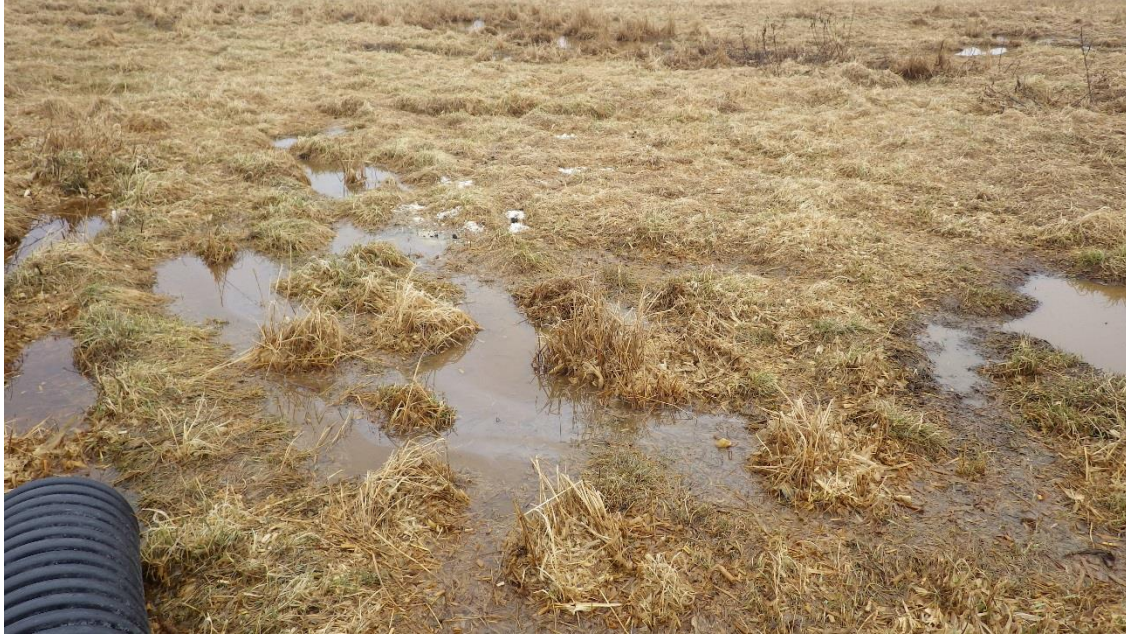
134: RIMG0143

Description: Process wastewater and feed solids observed in the grassed area.

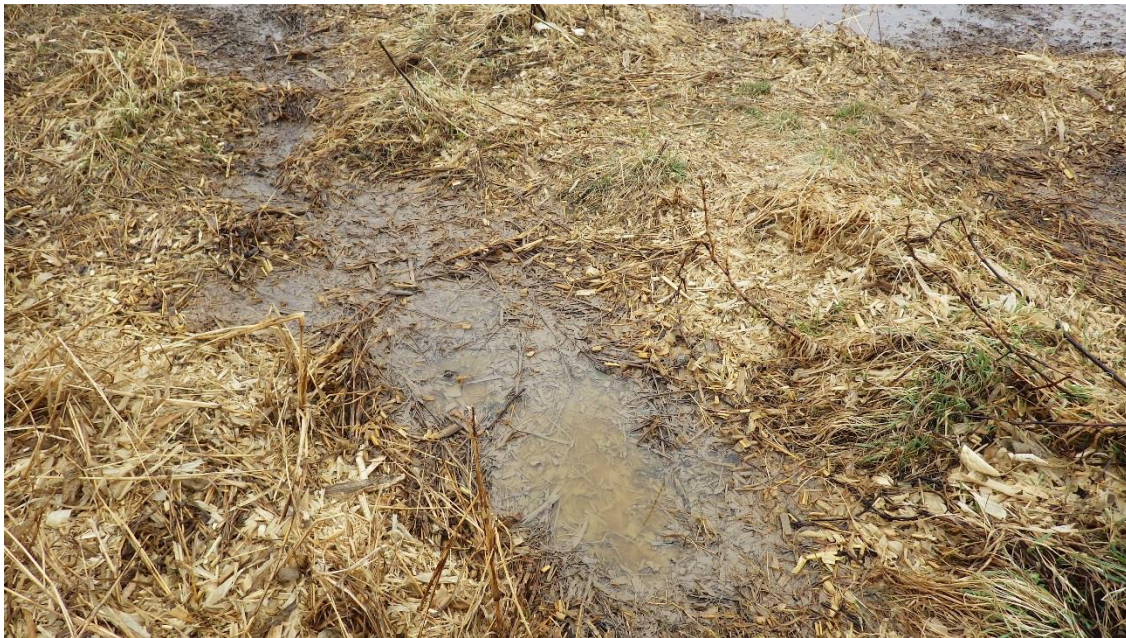
135: RIMG0144

Description: Process wastewater and feed solids were observed throughout the grassed area.

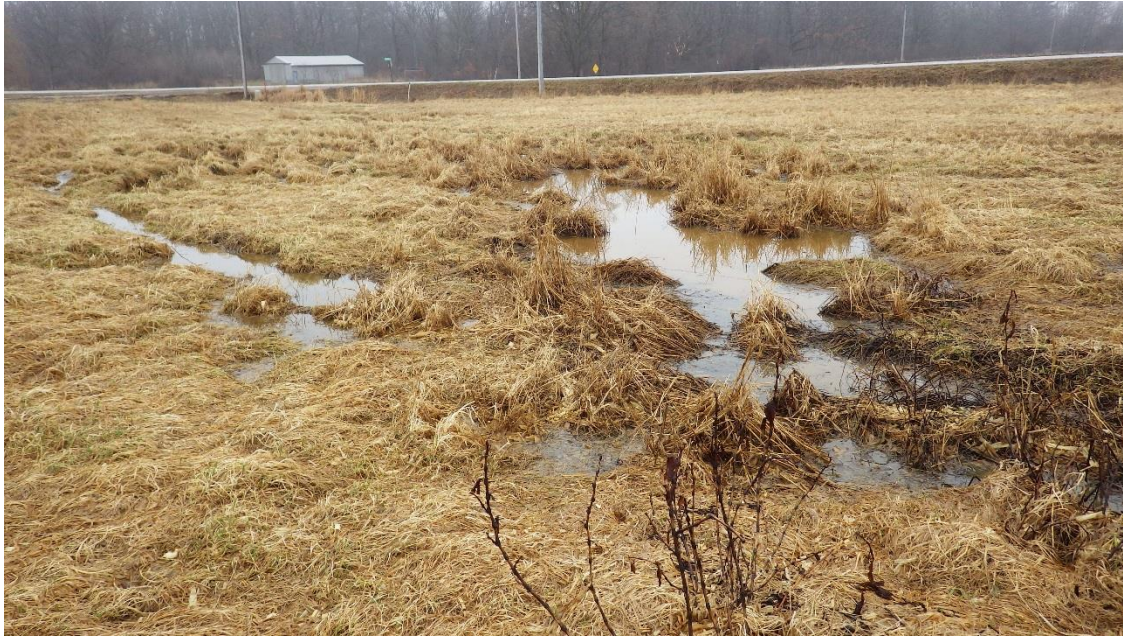
136: RIMG0145

Description: Process wastewater and feed solids were observed throughout the grassed area.

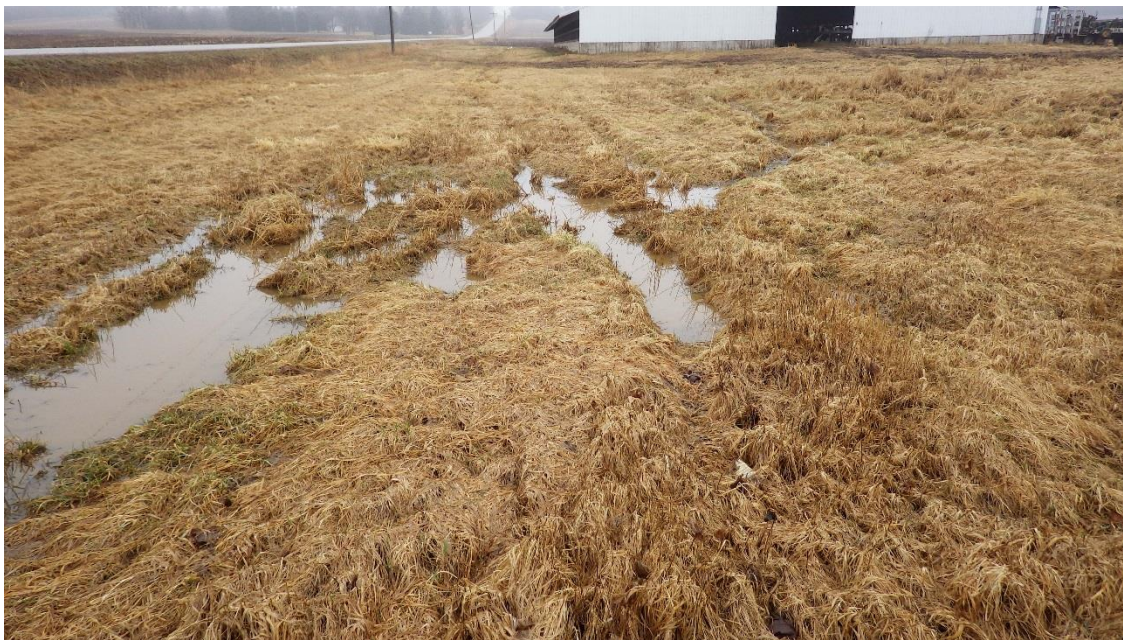
137: RIMG0146

Description: Process wastewater and feed solids were observed throughout the grassed area.

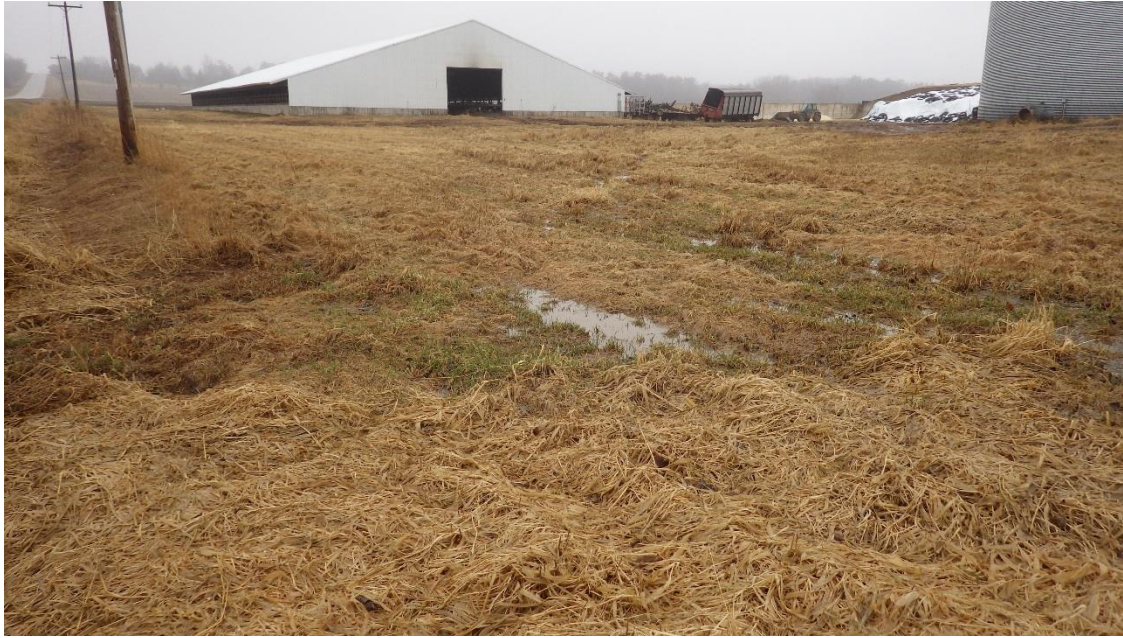
138: RIMG0147

Description: Process wastewater and feed solids were observed throughout the grassed area.

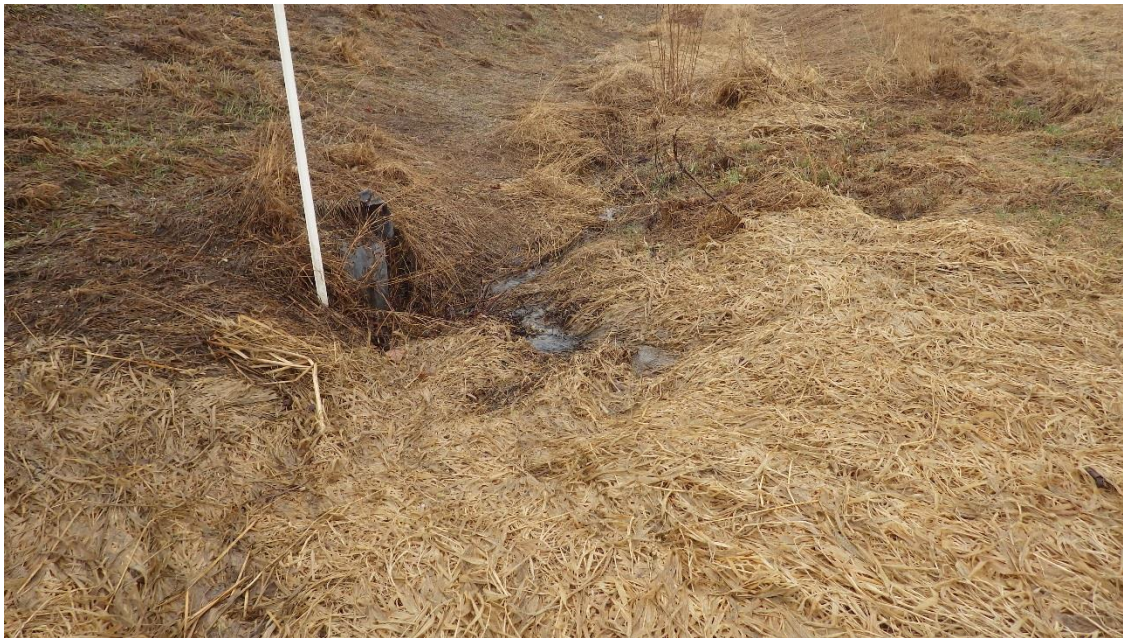
139: RIMG0148

Description: Process wastewater and feed solids were observed throughout the grassed area.

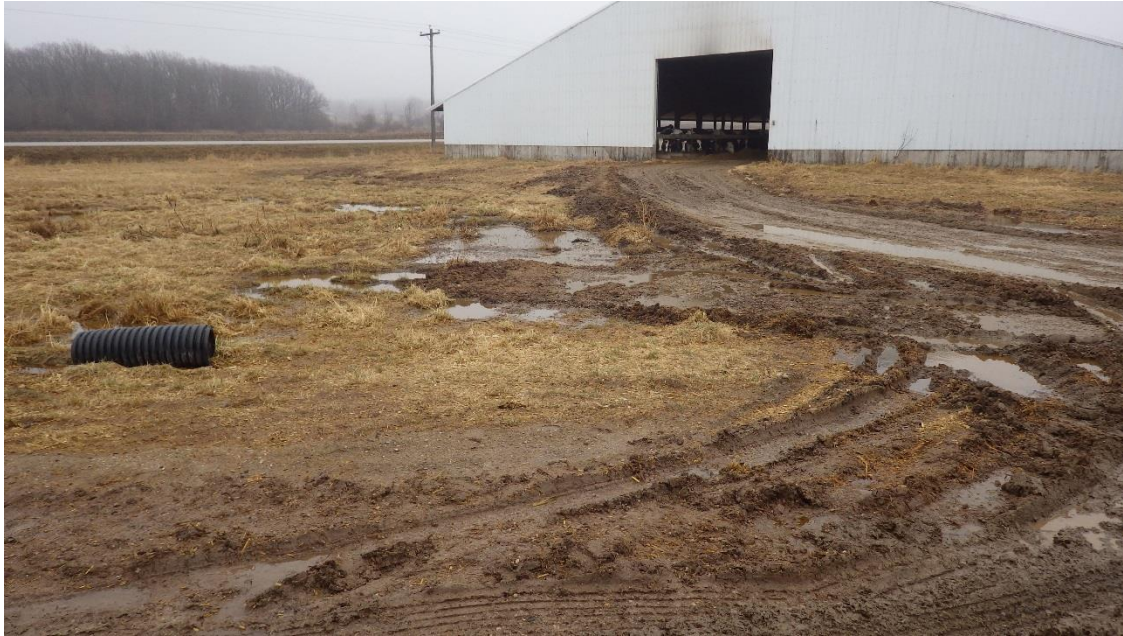
140: RIMG0149

Description: The process wastewater continued through the grassed area and outlet into the ditch. The culvert collected the flow which continued east under County Road V and east along the Silver Lane then north and continued northeast before connecting with an unnamed tributary

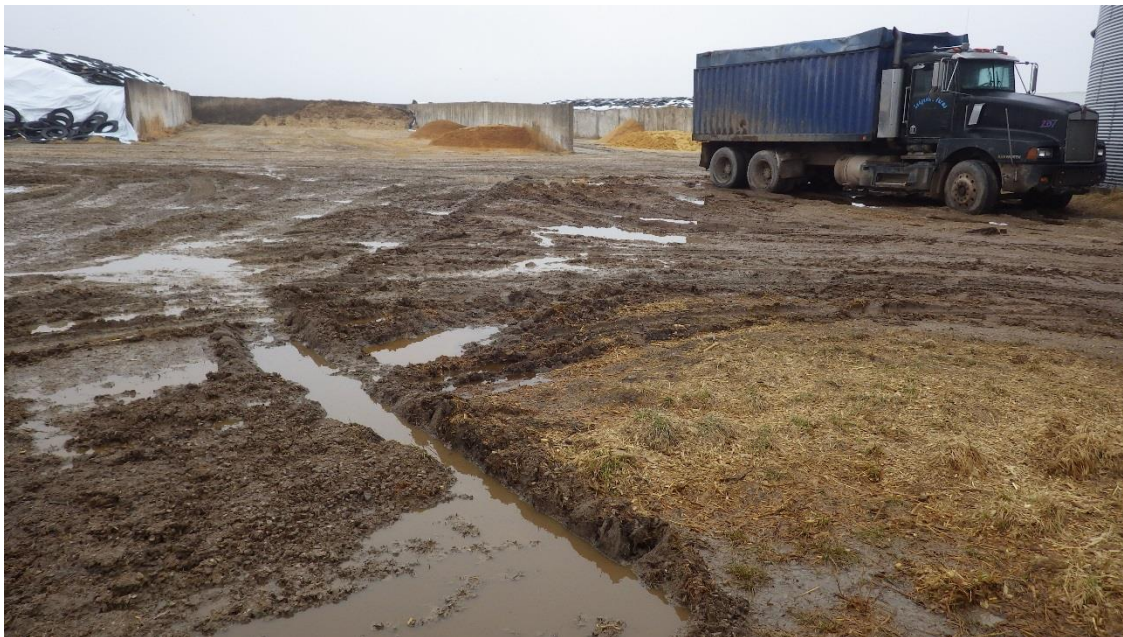
141: RIMG0150

Description: Process wastewater and feed solids were observed throughout the grassed area and the drainage paths leading to the grassed area.

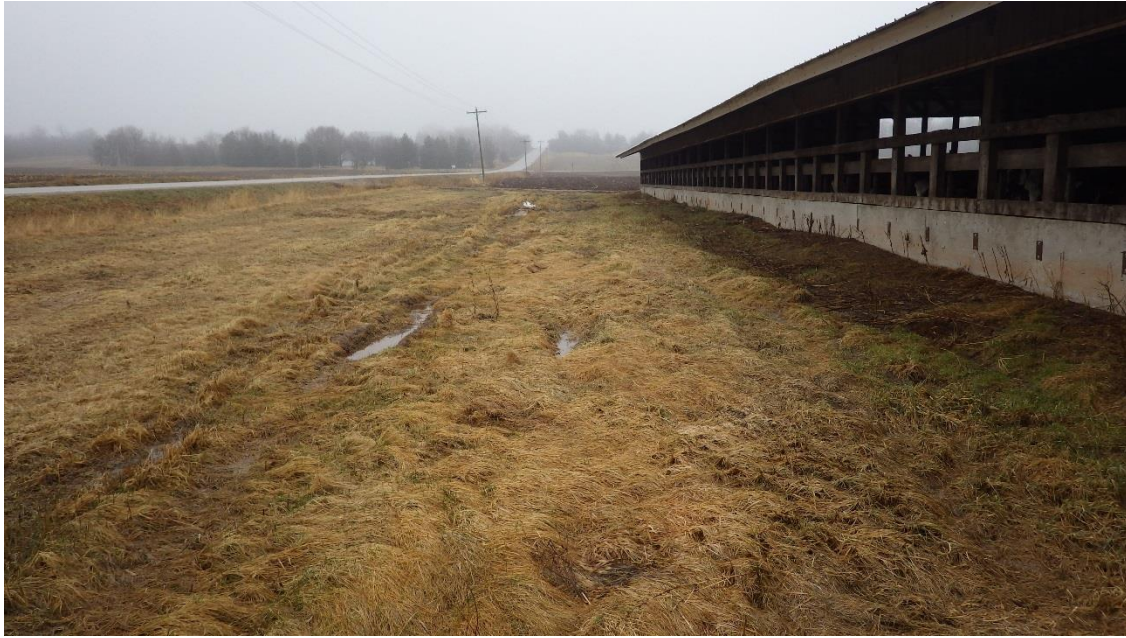
142: RIMG0151

Description: Process wastewater and feed solids were observed throughout the grassed area and the drainage paths leading to the grassed area.

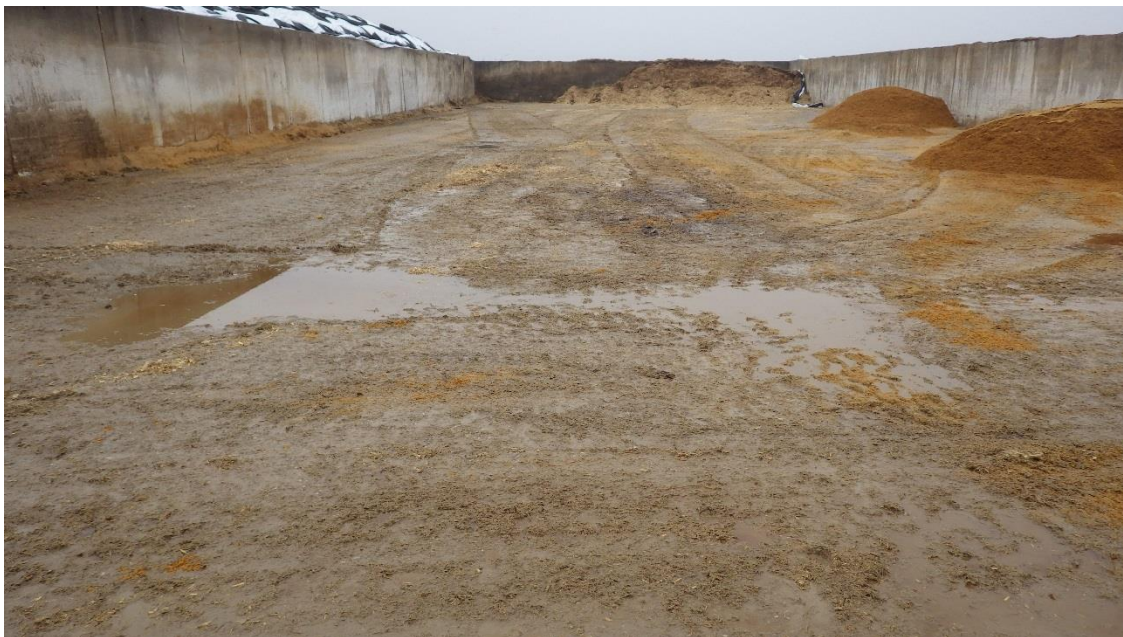
145: RIMG0154

Description: Drainage pathways from the feed bunkers flowed east to the grassed area. Process wastewater and feed solids were observed throughout the drainage pathways and the grassed area.

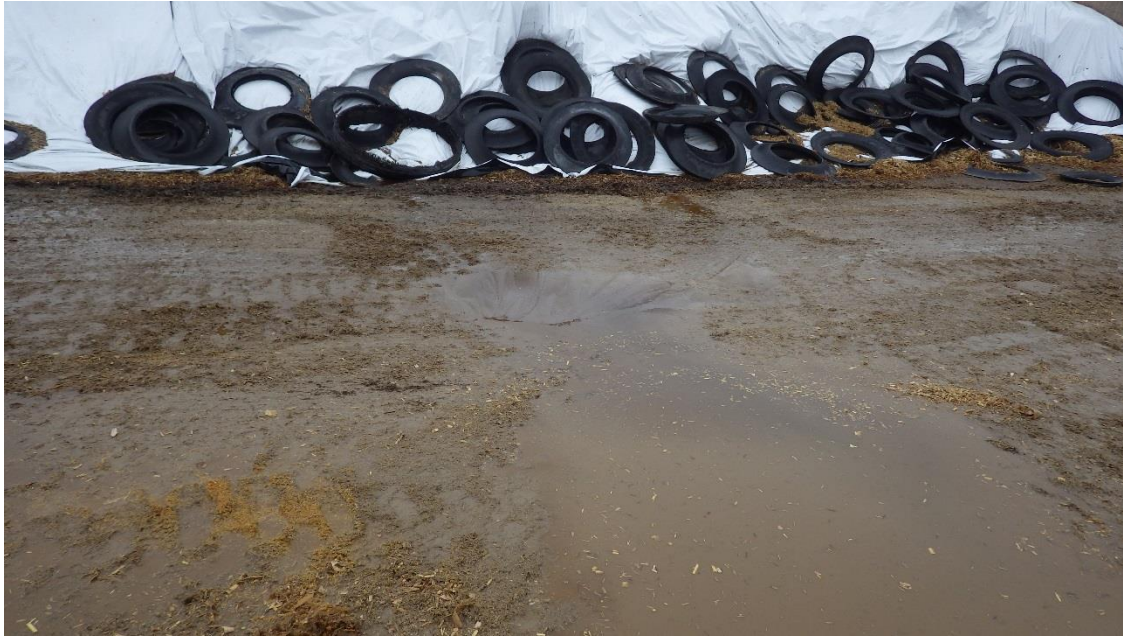
146: RIMG0155

Description: Drainage pathways from the feed bunkers flowed east to the grassed area. Process wastewater and feed solids were observed throughout the drainage pathways.

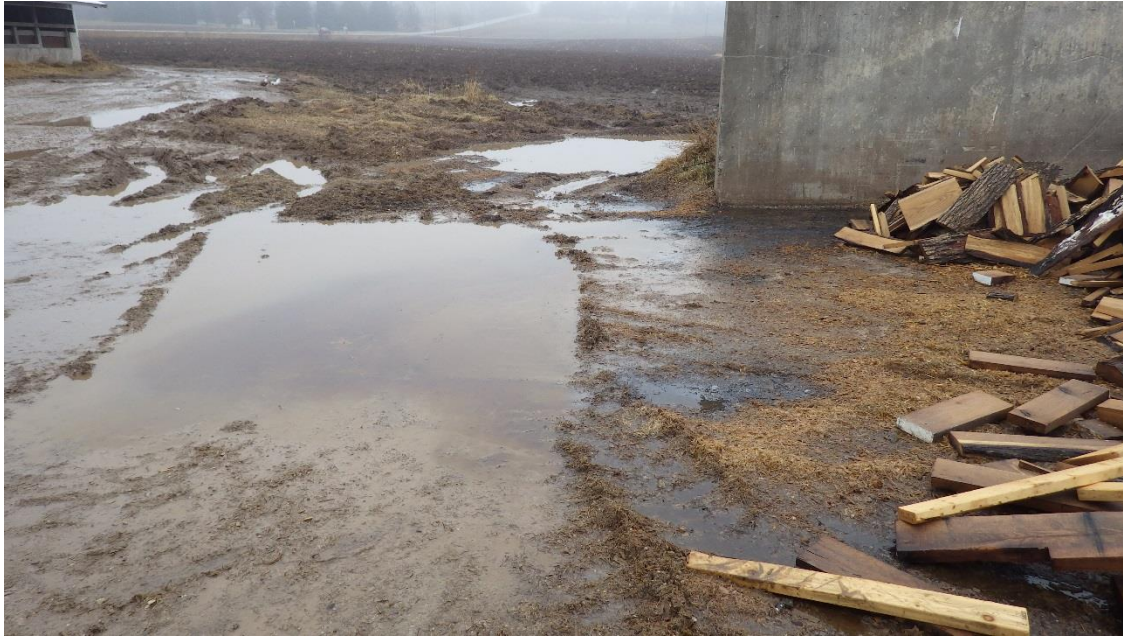
Description: Drainage pathways from the feed bunkers flowed east to the grassed area. Process wastewater and feed solids were observed throughout the drainage pathways.
